EXCAVATION AND REPAIR OF SUN TEMPLE MESA VERDE NATIONAL PARK

DEPARTMENT OF THE INTERIOR
OFFICE OF THE SECRETARY
1916

EXCAVATION AND REPAIR OF SUN TEMPLE.

By J. WALTER FEWKES, *Bureau of American Ethnology.*

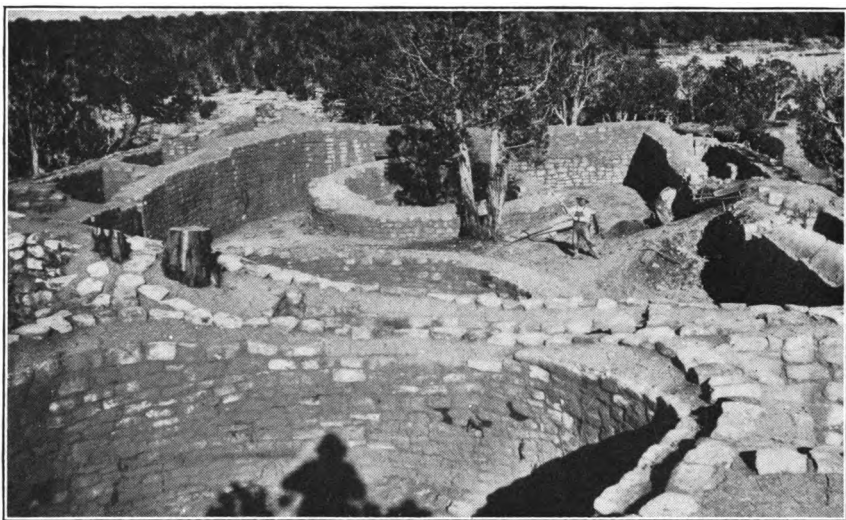
FIG. 5.—INTERIOR OF RUIN, LOOKING EAST, SHOWING CEDAR STUMP.

shown as on the facing of the outer walls. Roots of trees formerly growing on the ruin have made their way between the courses of stone and can still be seen in the walls.

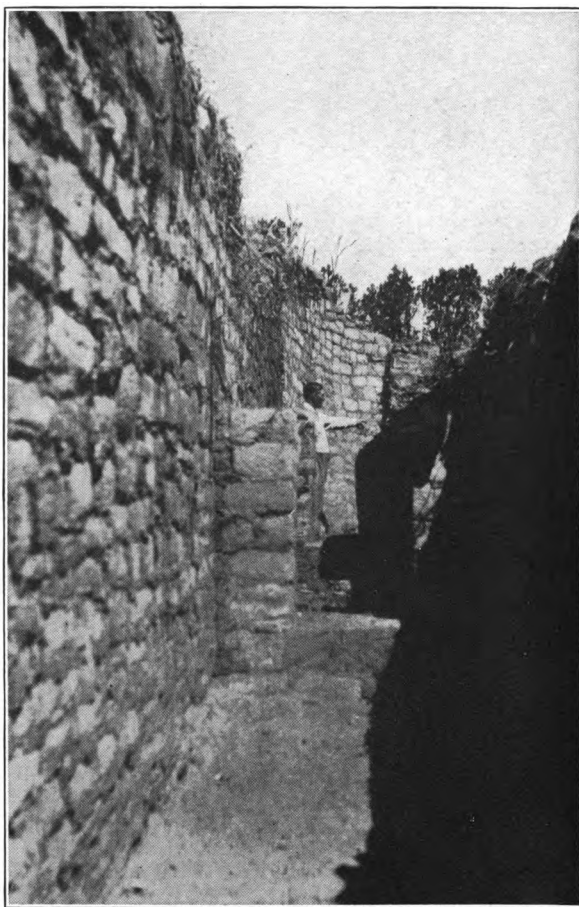
FIG. 8.—WEST WALL OF ROOMS *d* AND *e*, SHOWING DOORWAY.

t-v. The lintels which remained were much decayed and sagged under the weight of the wall above them, so much so that a brace of modern construction was introduced to support them. The lintel that held up the covered doorway of room *r* and that which supported the floor of room *z* above the trench leading into kiva A, were partially intact, but most of the lintels had to be replaced by modern beams, the originals being much decayed (fig. 8).

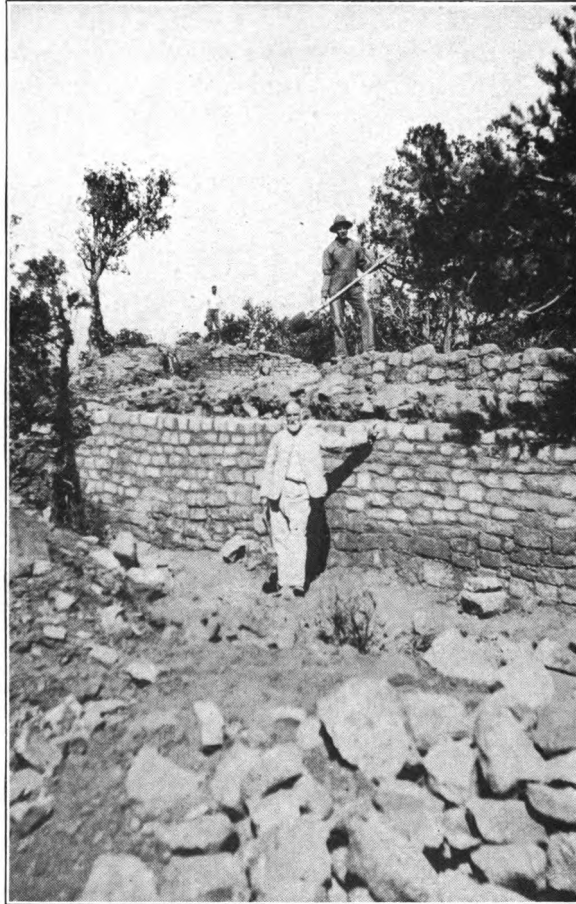
The main causes of destruction of this ruin were not vandals, as at Cliff Palace, but the elements, especially water. After it was abandoned the tops of the walls were exposed to the sky and unprotected either from snow or rain which sometimes falls in torrents. The snow was particularly damaging, for the water from the melting snow percolated between the facings and the core of the wall, and subsequently froze, forcing the facing of the wall away from the central core until it fell. That this was the main cause of deterioration is shown by the fact that as a rule the outer facing of the surrounding wall was more nearly obliterated to a lower level than the inner, and as a rule the core projected often a foot above faces of the wall. The deleterious cause which early led to the overtopping and destruction of walls would be even more potent when they were excavated. Some means had to be devised to prevent a continuation of their destruction (fig. 11).

FIG. 11.—PART OF SOUTH WALL, PARTLY EXCAVATED.

Although the walls of the building were so massive that they remained intact to the height of the top of the mound, they were partially held up by an accumulated débris. The removal of earth and fallen rocks weakened them so much that some provision had to be made to counteract this loss of support. In order to prevent the

water from melting snow from penetrating the walls, or the rain from percolating between the core of the wall and its facing, I placed a cap of cement on the tops of all the walls. The inner facing of the outer walls, as a rule, stood a few courses of stone higher than the outer, and it was necessary to add masonry to bring the outer wall to the level of the core and inner facing. Having leveled the top of

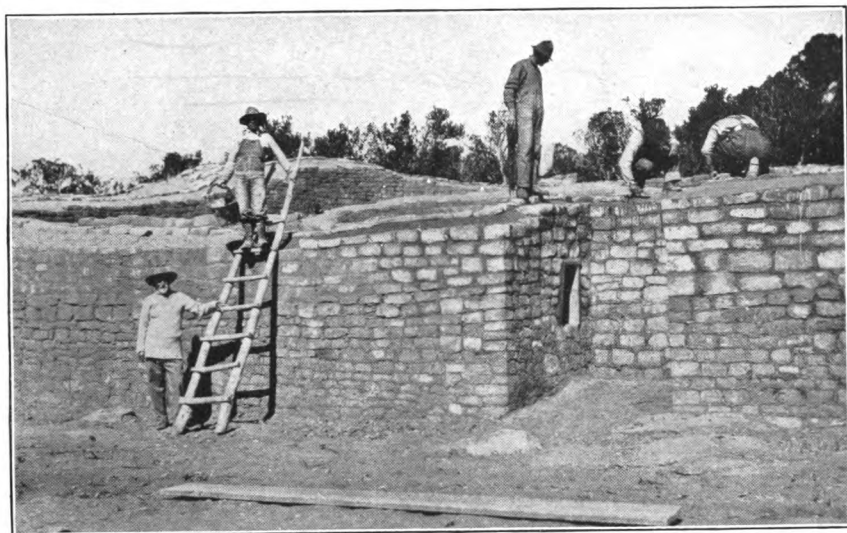
FIG. 12.—CEMENTING WALL OF RECESS IN SOUTH WALL.

the wall, I covered it with small, angular fragments of stone, placing these fragments highest in the middle or over the core. Over this roof-like covering was spread a thick layer of adobe. The top of the wall was thus made in a way to shed water. Over this roof of adobe was spread a layer of Portland cement, 2 inches thick, mixed in proportion of 1 to 5, care being taken to use this cement freely in point-

ing the joints in the facing of the wall in order to prevent the entrance of water in the cracks (fig. 12). The roof shape of this covering or the fact that it is highest in the middle will shed the water and throw it away from the wall without harm. The layer of cement protects the adobe used in pointing the walls and prevents it from being washed from between the stones. Direct action of rain beating on the surface or outside of the wall could not be prevented in this way.

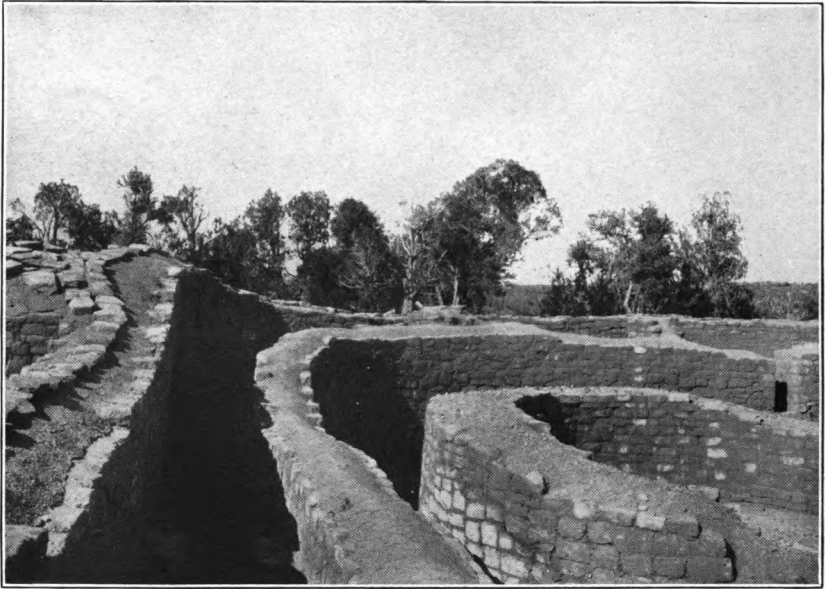
FIG. 13.—WEST ROOMS OF ORIGINAL BUILDING.

wearing away of the cement by anyone who desired to walk on top of the walls, a row of stepping stones (fig. 13) firmly set in place was provided.

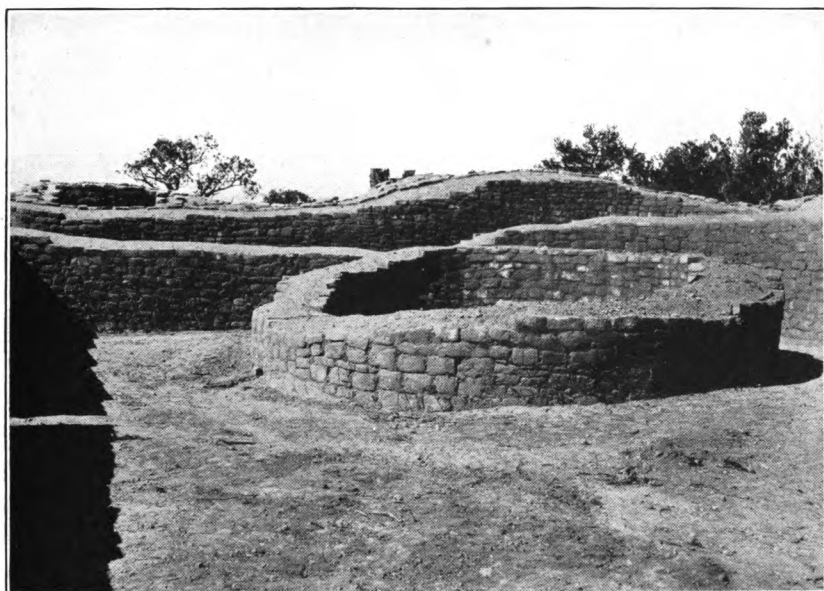
mound. No one can tell the length of this interval in years. We have, however, knowledge of the lapse of time since the mound had accumulated enough soil on its surface to support growth of large trees. In the Annex, between rooms *r* and *s*, near the summit of the highest wall, which is 11 feet 3 inches high, there grew a juniper or red cedar of great antiquity, alive and vigorous when I began work. This tree undoubtedly sprouted after the desertion of the building, and grew after a mound had developed from fallen walls. Its roots penetrated into the adjacent rooms and derived nourishment from the soil filling them. Necessarily when these roots were cut off, thereby killing the tree, I was obliged to fell it, but the stump remains, cut off about a foot above the ground (fig. 14). Three hundred and

FIG. 14.—WEST END OF PLAZA, SHOWING KIVA B AND STUMP OF OLD CEDAR.
