EXCAVATION AND REPAIR OF SUN TEMPLE MESA VERDE NATIONAL PARK

DEPARTMENT OF THE INTERIOR
OFFICE OF THE SECRETARY
1916

EXCAVATION AND REPAIR OF SUN TEMPLE.

By J. WALTER FEWKES, *Bureau of American Ethnology.*

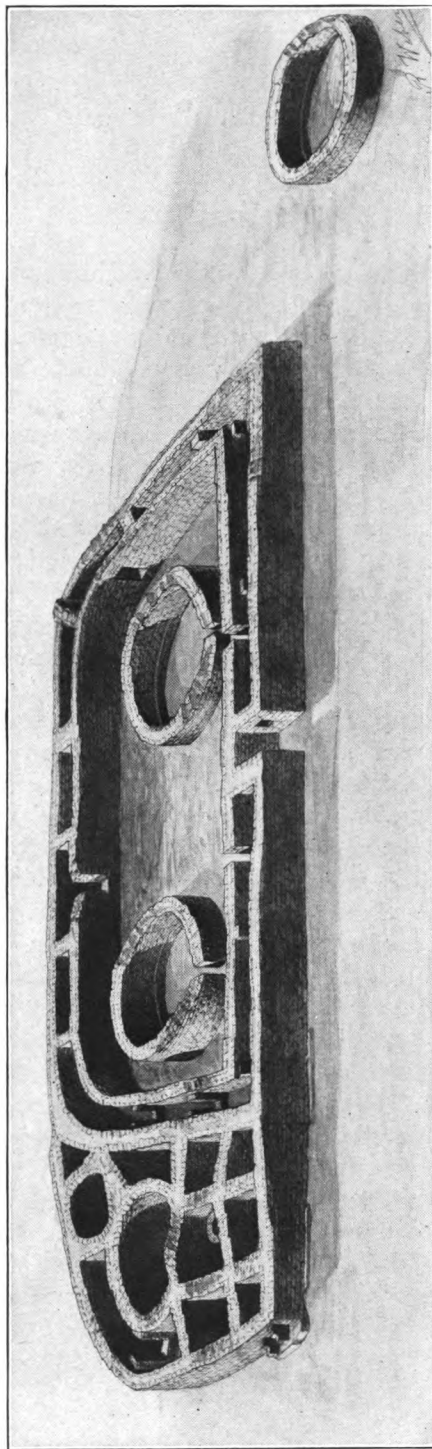
FIG. 1.—BIRDSEYE VIEW OF SUN TEMPLE, LOOKING NORTHEAST.

Slightly south and east of a continuation of the eastern end of the south wall lies a circular building with walls 4 feet thick, which has some resemblance to a kiva, and closely resembles the base of a tower (fig. 1). The commanding site of this structure would seem to favor the theory that it was formerly a lookout, but the few courses of worked stones forming the base of the wall show that it was never erected to any considerable height. From its conspicuous position this building overlooks the great canyon at the south of the mesa and from it one can look down Soda Canyon to Mancos River or across Cliff Canyon to the round tower in Cliff Palace. This was probably intended for a ceremonial room, but may have been a lookout or tower. There is ground to believe that none of the so-called towers of the Mesa Verde, Mancos, or Montezuma valley were observatories, but, like the celebrated "tower" in Cliff Palace, were for ceremonial rites connected with sun worship. The floor of this unfinished circular building is very uneven; it is made by the natural surface of rock in place with projections that rise slightly higher than the level surface of the cliff outside. This building has no indications of fireplace or other essentials of a cliff house kiva, and the inner wall was faced with smaller, well-dressed stones like the kivas of the main buildings.

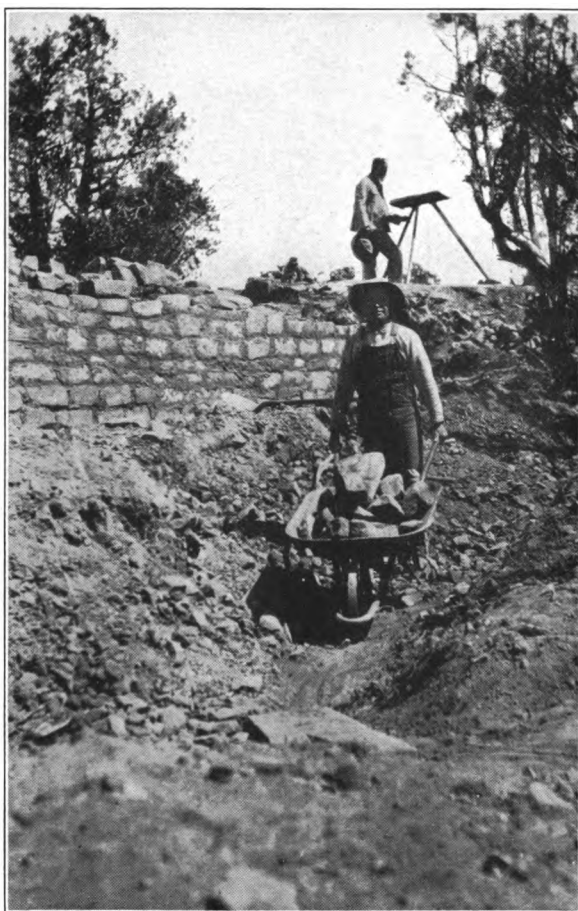
The stones out of which the walls were constructed were quarried on the mesa top near the ruin and are of the same sandstone as the cliff. They vary in size and in degree of hardness, some specimens being so soft that their surfaces may be rubbed off by hand. On account of the softness of these rocks it was not a difficult feat to fashion them into shape; a few blocks were dressed into perfect cubes, their faces being at right angles. There was an attempt to lay stones of the same thickness in the same course, but often lines of thick stones alternated with stones half as large (fig. 6). Stones were blocked into shape by cutting grooves on opposite faces and

FIG. 6.—SOUTH WALL, LOOKING WEST.

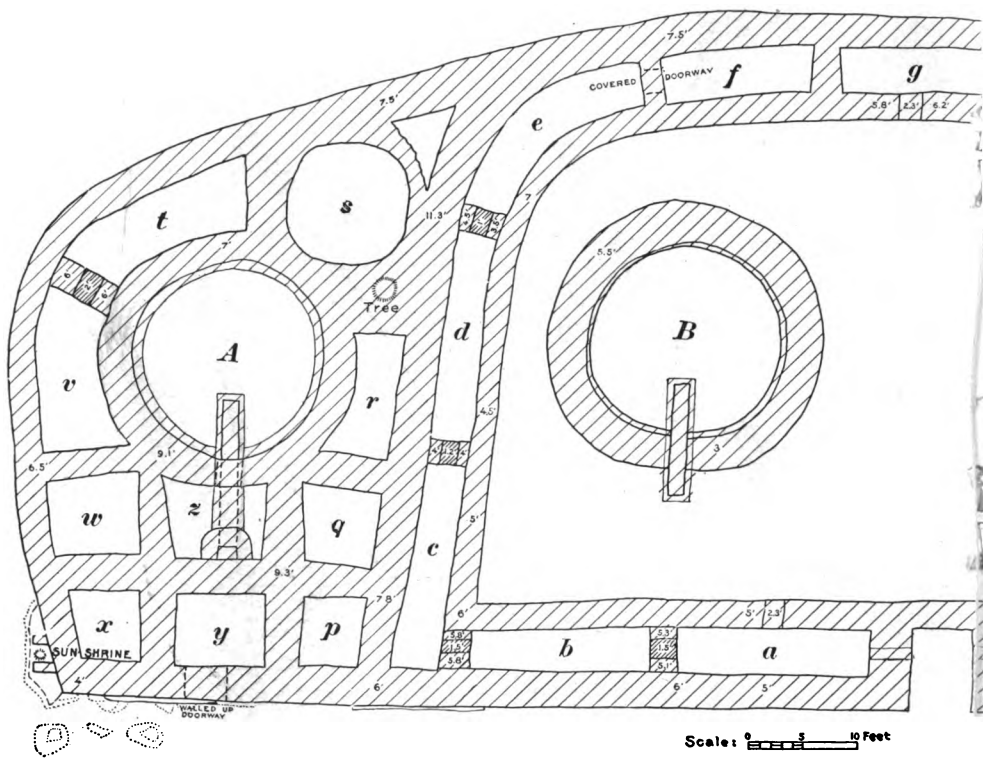
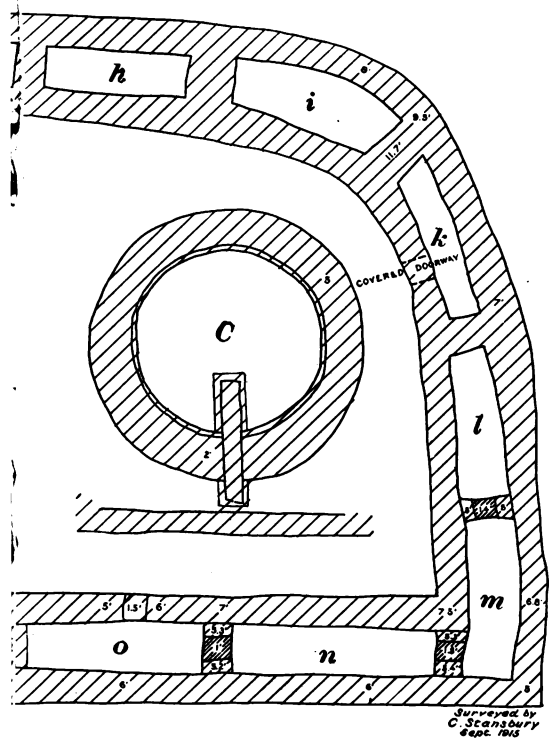
The ground plan, shown in figure 7, has been well compared to the letter D. The building is formed of two sections, the larger of which taken separately is also D-shaped and may be called the original building, while the smaller, forming the west end, is of later (?) construction and may be known as the Annex. The south wall, which is straight, is common to both original building and Annex and extends from the southeast corner of the ruin directly east-west 121.7 feet. The portion of this wall from the recess to the east corner has exactly the same length as that to the junction of the original building with the Annex. The western end of the original building, on the south

FIG. 7.—GROUND PLAN OF SUN TEMPLE, MESA VERDE NATIO

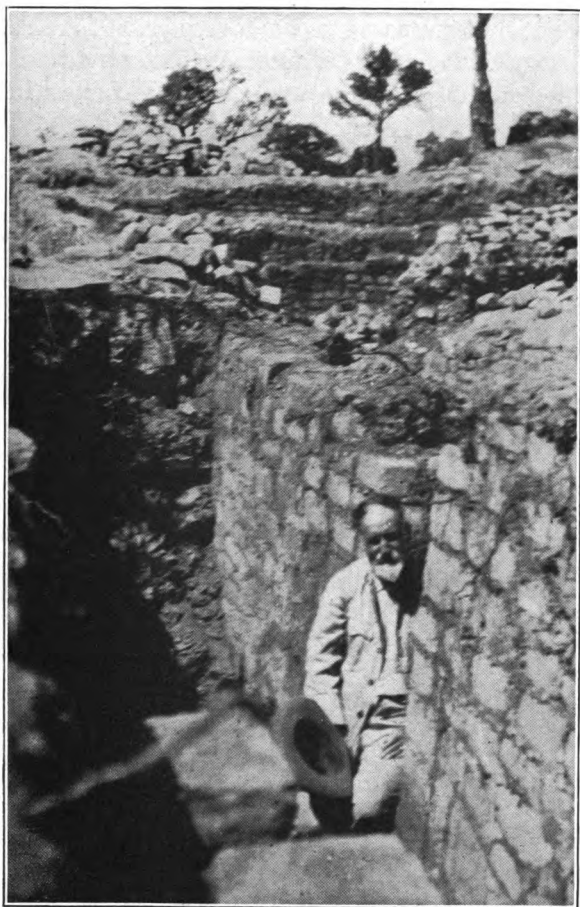
FIG. 9.—WEST END OF ROOM *o*, PARTLY EXCAVATED.

Four of the rooms surrounding the plaza were entered directly by doorways; one of these led into room *a*, others into rooms *g*, *k*, and *o*. The thresholds of the doorways are commonly constructed of large, flat, well-trimmed stones. On each side of the doorway are pilasters (fig. 9) the walls of which are upright and the corners made of good masonry (fig. 9). Evidently all the doorways once had wooden lintels

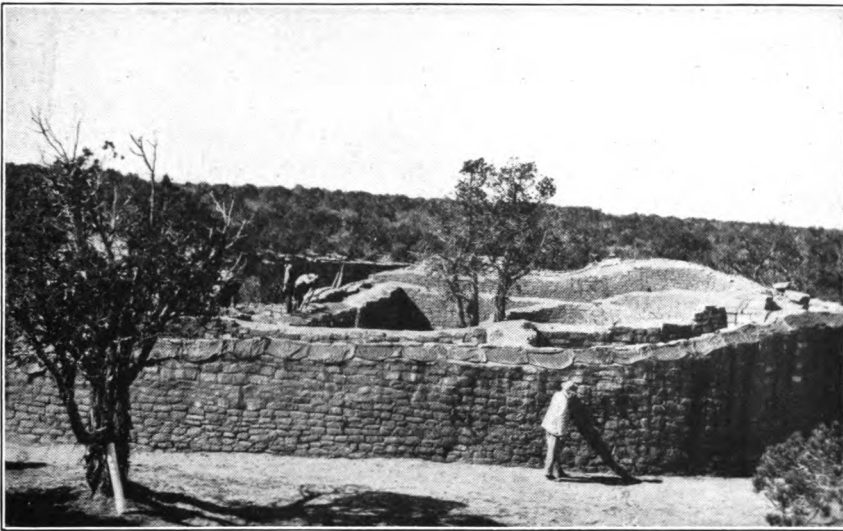
FIG. 15.—OUTER NORTHEAST WALL.

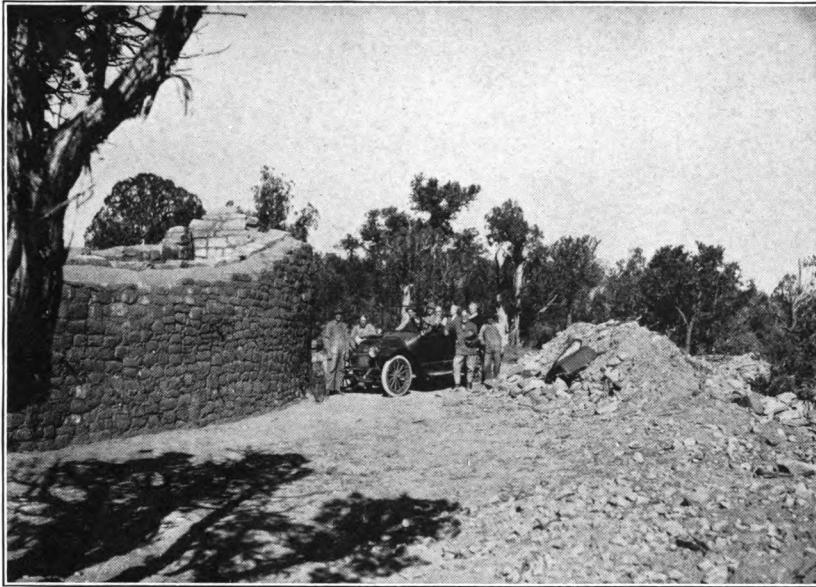
FIG. 16.—FIRST AUTOMOBILE TO ROUND THE RUIN, NEAR NORTHEAST WALL.

sons. In order to facilitate access to Sun Temple a road was constructed around the ruin for automobiles (fig. 16), so that one can now alight a few steps from any point of the walls. The automobiles themselves practically made the road through the cedars to camp.
